Nine Minimum Controls – No. 5

5.0 ELIMINATION OF CSOs DURING DRY WEATHER

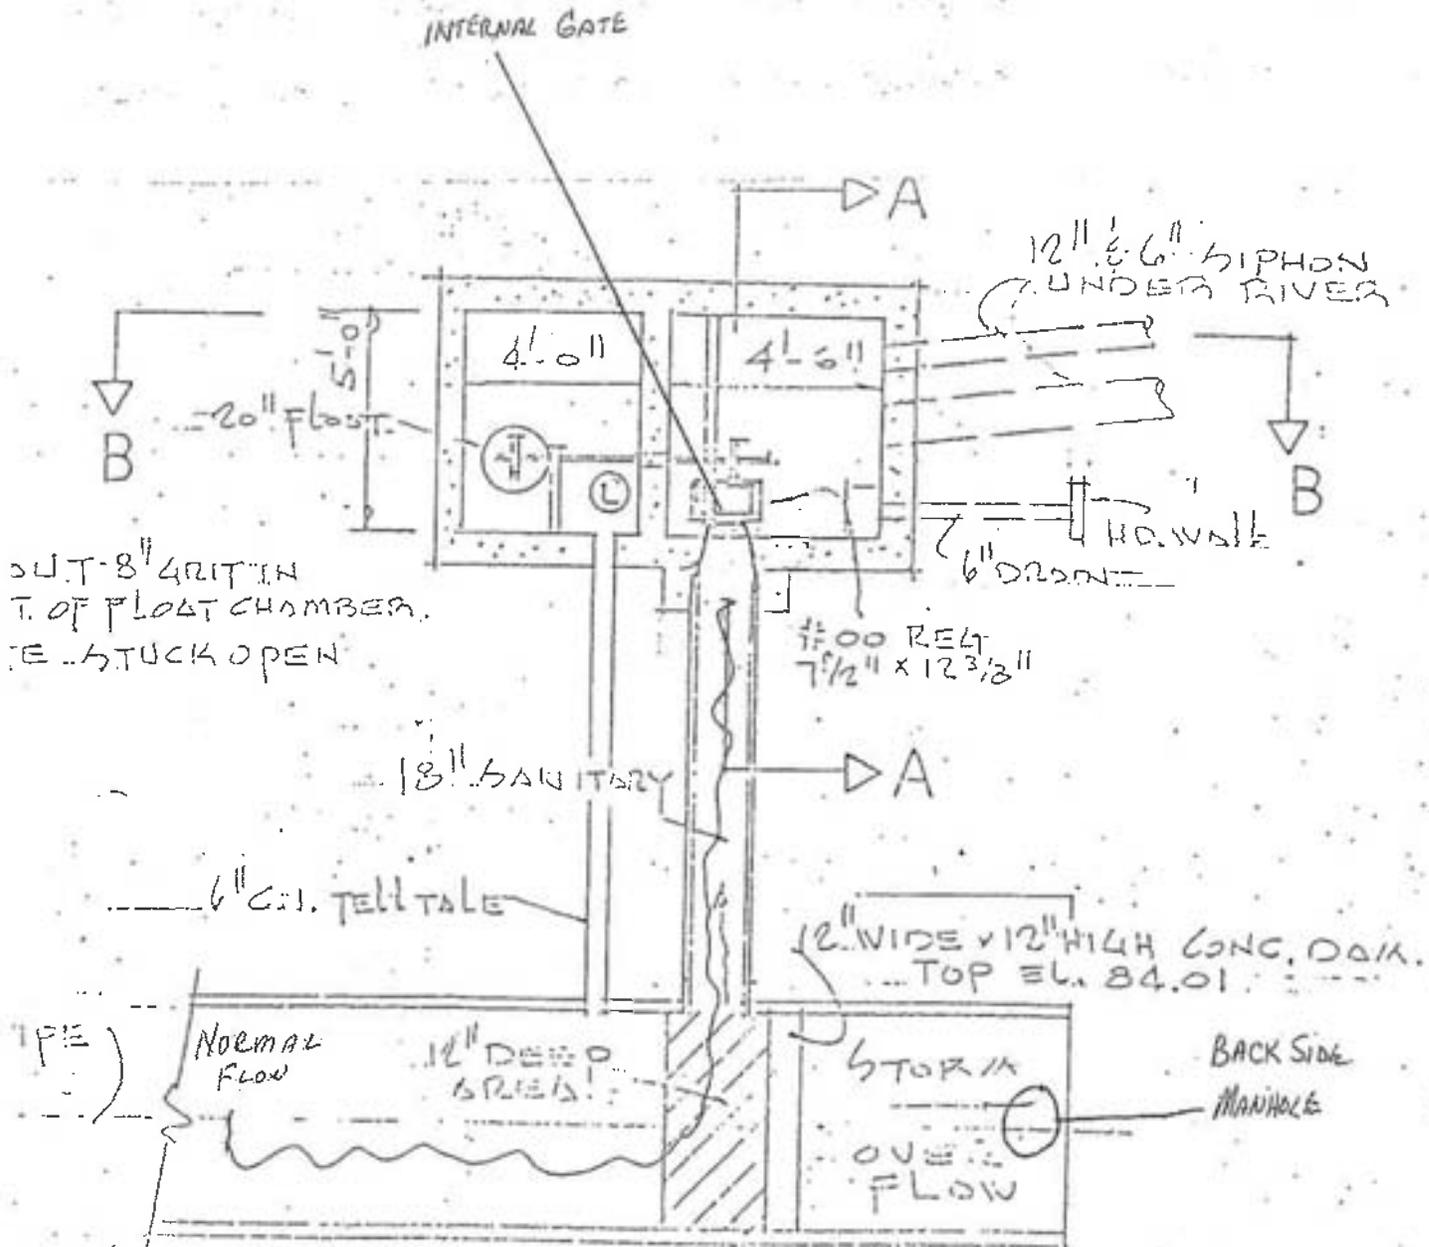
AS YOU CAN SEE THE PIPE NARROWS AT THE INTERNAL GATE. WE BELIEVE THE OPENING IS SMALLER THAN THE PIPE MAKING IT VERY DIFFICULT TO GET THROUGH FROM THE BACK SIDE. WE HAVE TRIED TO OPEN FROM THE INTERNAL GATE SIDE BUT THE GATE ITSELF PREVENTED US FROM DOING SO. COULD THE PLANT REMOVE THE GATE? THIS IS ALOT CLOSER TO THE PROBLEM AND WE COULD POSSIBLY SEE IT AND IDENTIFY THE ACTUAL PROBLEM.

Actions taken to mitigate, minimize, and prevent future overflows:
This problem is in a very difficult location and we are in the process of trying to eliminate some equipment as noted in the previous report dated 11-06-02. We removed a small amount of roots and some debris on 3-6-02. This stopped the overflow but we need to address a long term solution.
